**Test Report Number: 103439 Issue 1**

**Customer Name & Address:** Panorama Antennas Ltd  
61 Frogmore  
London  
SW18 1HF

**Test Sample(s) Description:** TRNC[G] Antenna Range  
TRNM[G] Antenna Range

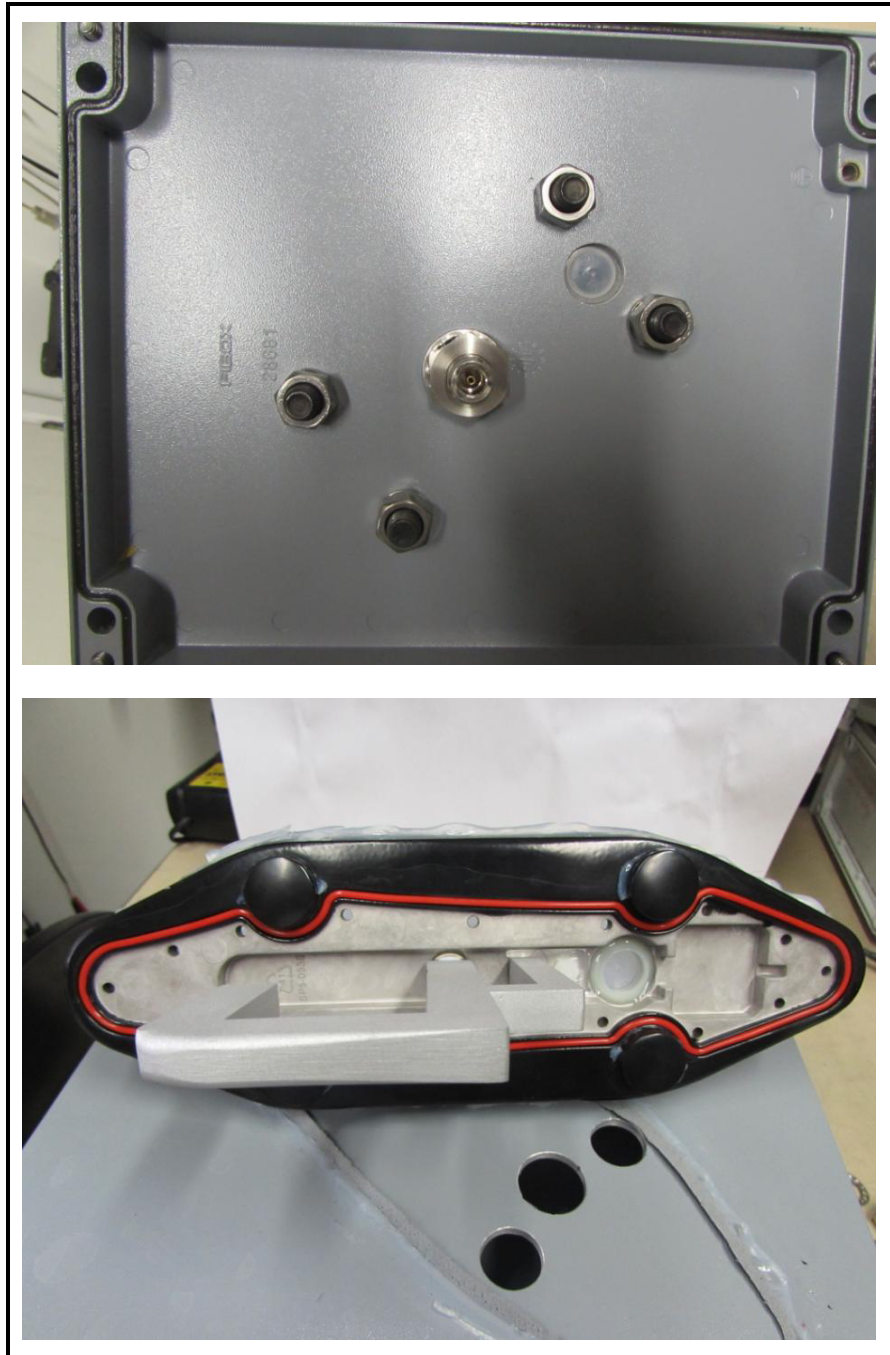
**Figure 2: Post Test Photos – IPx9K Water Ingress TRNC[G]**

On completion of the IPx9K test of the TRNC[G] Antenna Range Antenna, no signs of water ingress were observed within the case or the ABS enclosure.

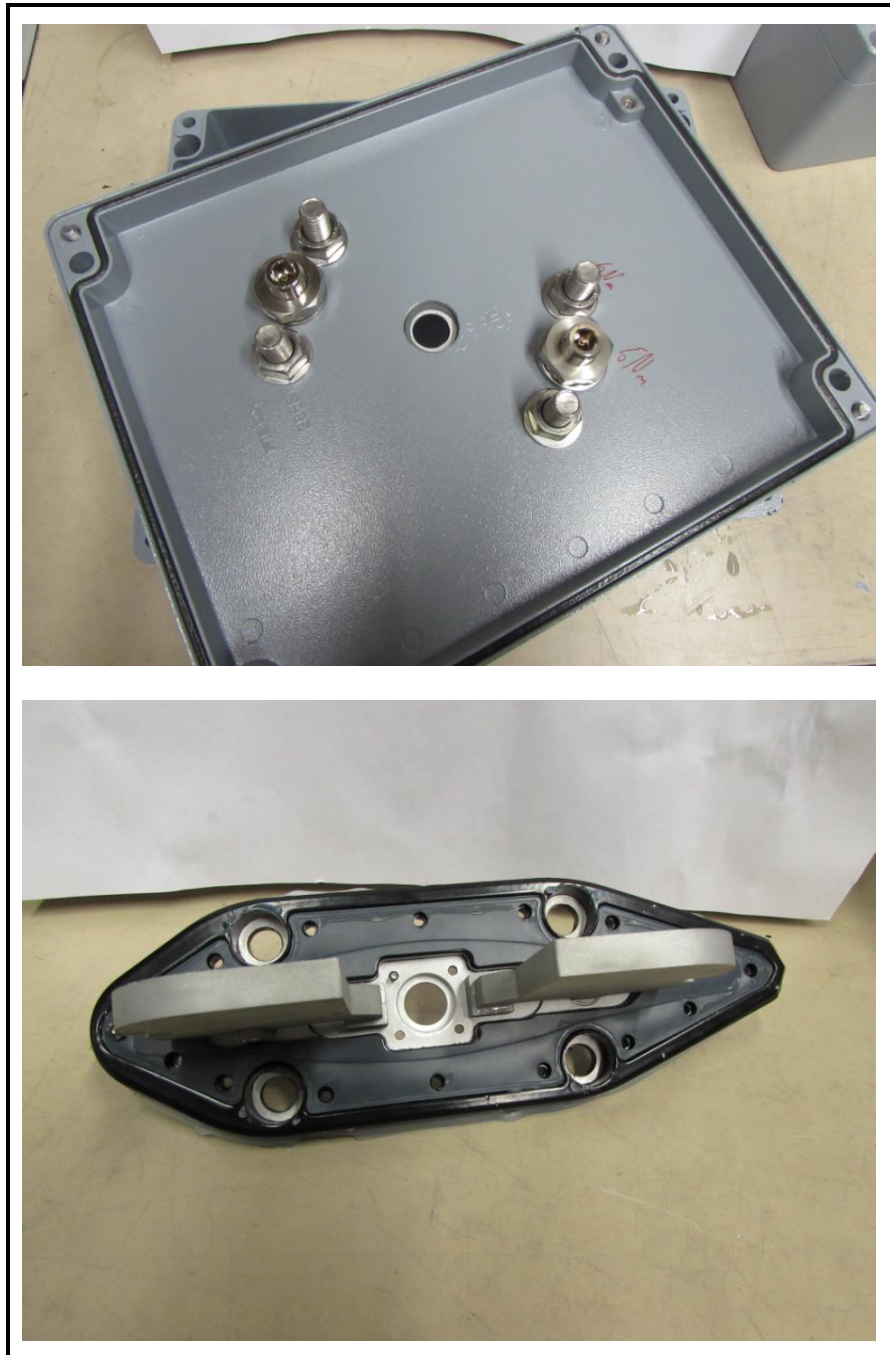
**Figure 3: Post Test Photos – IPx9K Water Ingress TRNM[G]**

On completion of the IPx9K test of the TRNM[G] Antenna Range Antenna, no signs of water ingress were observed within the case or the ABS enclosure.
